HOME INSPECTION

123 Any Street
City, ST Zip

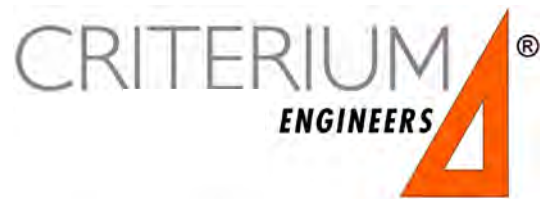
22 Monument Square
Portland, ME 04101
